UNDERWATER BRIDGE INSPECTION REPORT

STRUCTURE NO. 7183

ST. LOUIS RIVER

MINNESOTA DEPARTMENT OF TRANSPORTATION
UNDERWATER BRIDGE INSPECTION

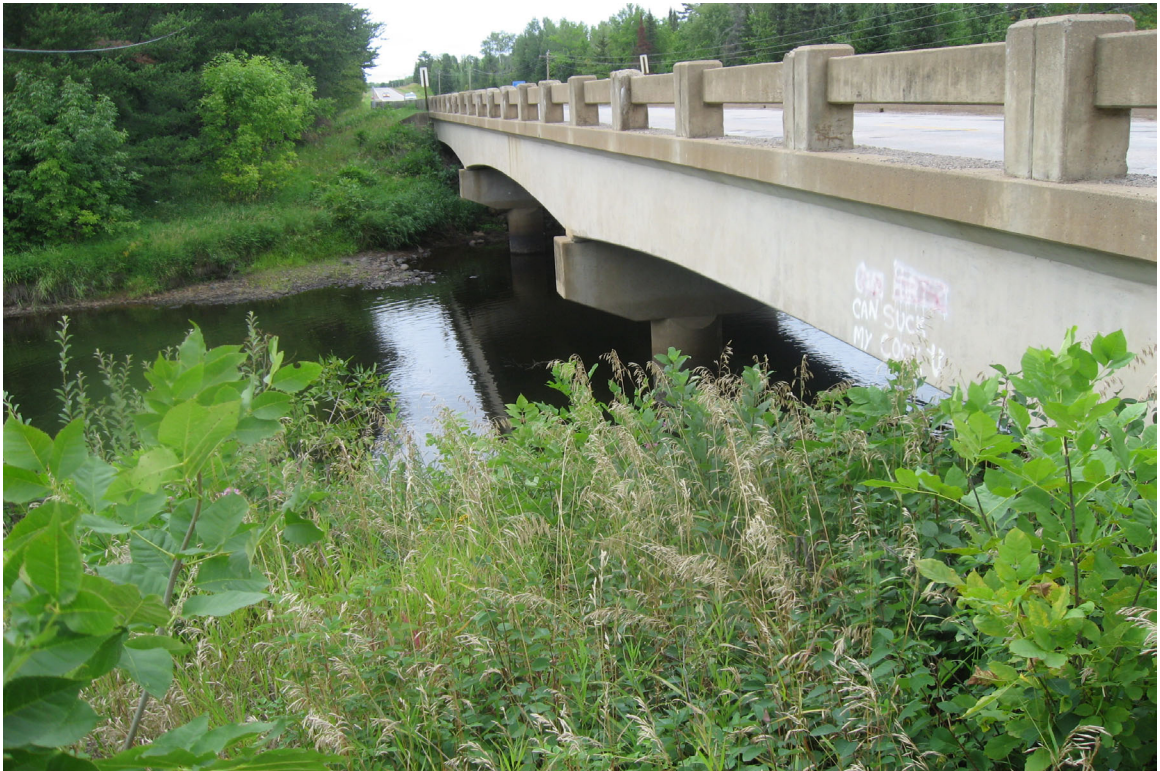
Photograph 1. Overall View of Structure, Looking Northeast.

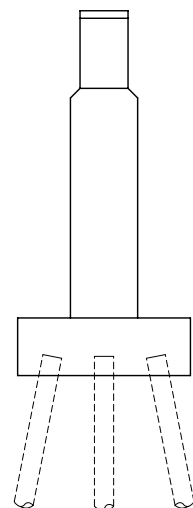
TYPICAL END VIEW OF PIERS

- 2 The channel bottom consisted of soft silt and organic material with 1.5 feet of probe rod penetration at the upstream column of Pier 2.
- 3 Light to moderate scaling with some aggregate exposure from 4 feet above the waterline to 1.5 feet below the waterline with typical penetrations of 1/8 inch and up to 1/4 inch maximum at the upstream columns. Heavier scaling was observed at the downstream columns with a maximum penetration of 1.5 inch at Pier 1 & 2.

- 4 An area of heavy scaling/section loss was observed around the downstream column of Pier 1, 2-foot-high by 2.5-feet-wide at 1 foot below the waterline with a maximum penetration of 1 inch.

- 5 A scour depression, 3 feet in radius with a depth of 2 feet, was observed at the upstream columns of Pier 1 & 2. The accumulation of timber debris was observed in the depression.

- 6 6-to 12-inch-diameter log was observed from the channel bottom to the waterline along Pier 1 & 2 as shown.
- 7 A light to moderate accumulation of 6-inch-diameter and smaller timber debris was at the upstream and downstream ends of Pier 1 & 2. Accumulations extended from the channel bottom up 3 feet.

Monitor the drift accumulations at both piers during future inspections, and if found to be increasing in size, removal of the timber debris during normal maintenance of bridge may be warranted.
